## **UNEXPECTED INTERGOVERNMENTAL COLLABORATION LEADS TO COAL ASH AMELIORATION OF SEWAGE IMPACTED SOIL DURING COVID-19**

Authored by: AKJ Surridge (SANEDI), KA Reynolds-Clausen (Eskom), HJ Davel (SANDF)

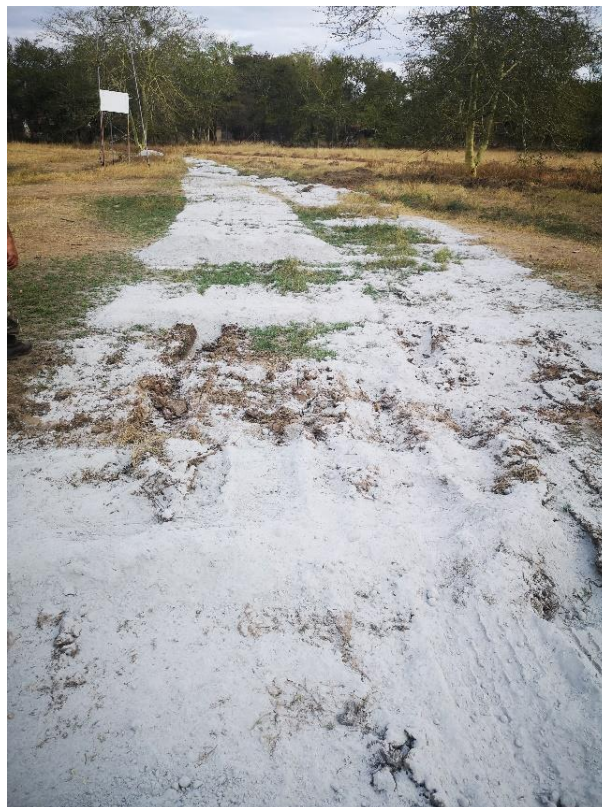
Ash applied on soil/spill surface (28 July 2020)

A rapid solution to the situation was required, to this end, the partners agreed on swift action and subsequently six tons of fresh run-of-station ash were secured from Medupi Power Station and applied to the affected area on 28 July 2020. The ash was not included in the soil,

but merely spread on the surface and into the gully that had formed through the liquid sewage runoff.

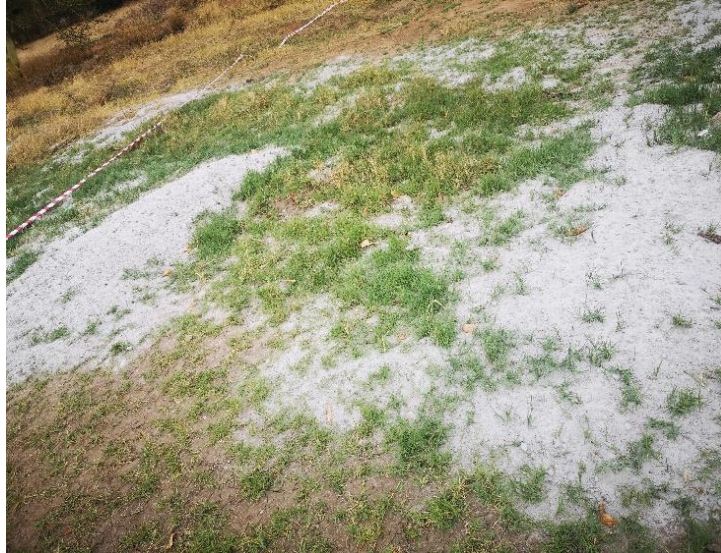
Ash at nine weeks after application, grass growth is beginning

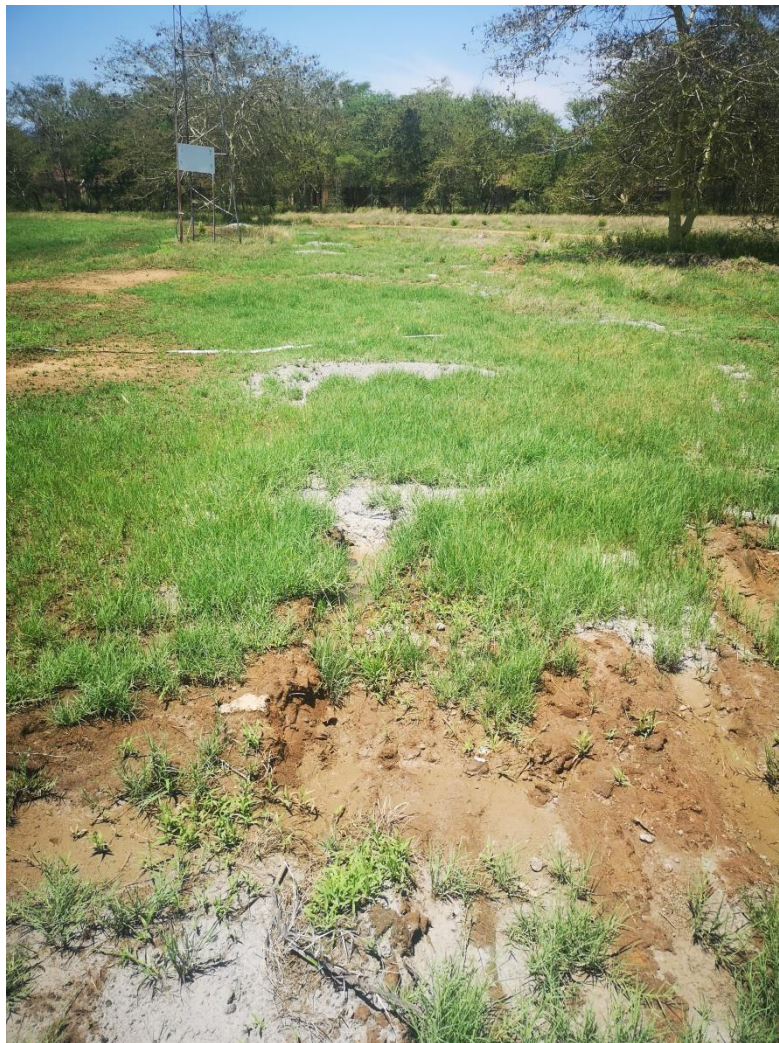
At four months, the ash has begun to naturally incorporate into the soil and grass cover is returning (November 2020)

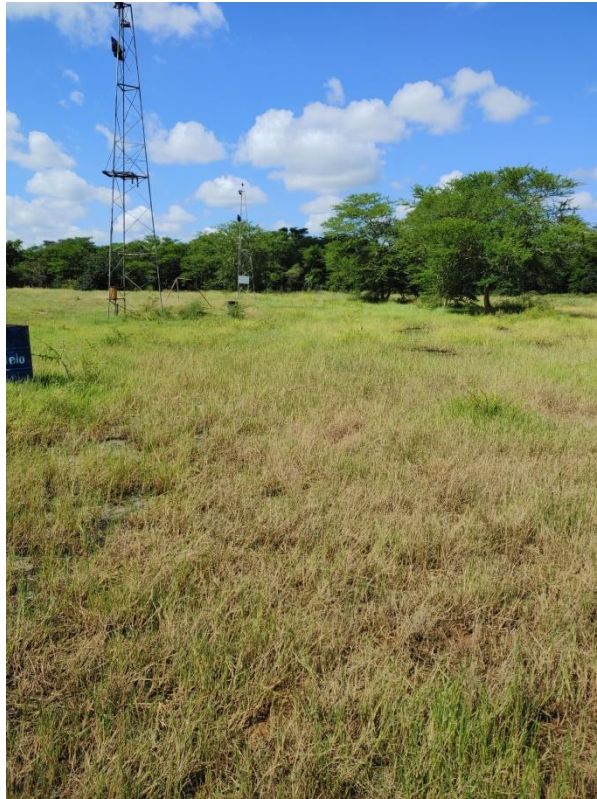
The affected area seven months after ash amelioration during summer (February 2021)

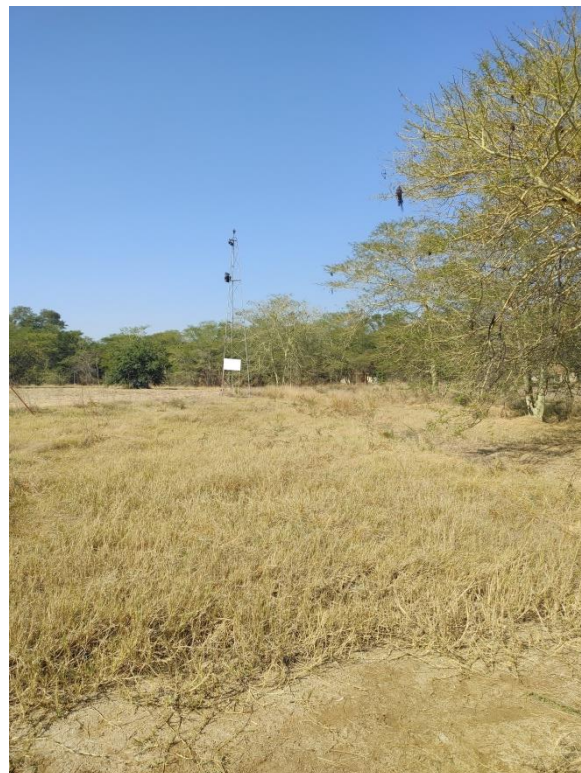
Showing seasonal surface growth rehabilitation of the area at 11 months after application and during winter (May 2021)

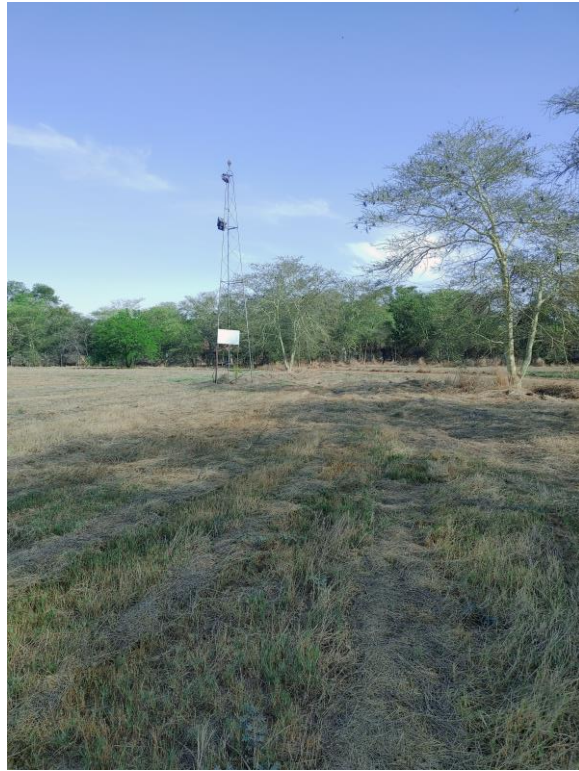
Showcasing complete rehabilitation as of October 2021.

As of October 2021, the area is deemed successfully and completely rehabilitated, and it displays an enriched flora/grass layer with a healthy activity of various interactions between all-natural role-players within a balanced diversity. Aesthetically, the area recovered to its former condition having no odours or sludge detectable. Scientifically it has been proven in other studies that soil with slightly higher lime content (pH), improves the palatability and nutritional value of plants and although this was not evaluated, it can be assumed to have occurred in this instance. This collaboration between government entities has once again proven that teamwork and swift action benefited the community and environment.
